ANALYSIS REPORT

Test parameter: Strong jet water test IPX6 according to DIN EN 60529: 2014-09
Steam jet test test IPX9K according to ISO 20653: 2013-02

Specimens: Empty housing
Quantity of specimens: 4
Name of specimens: Specimen 001 (T07 empty housing VA0.1.K1.BOR)
Specimen 002 (T07 empty housing VA2.3.K3.BOR2)
Specimen 003 (T07 empty housing VA2.3.K3.BOR5)
Specimen 004 (T07 empty housing VA4.1.K.PS1)
Sampling: Customer
Sample storage: Solid samples 4 weeks and liquid samples up to 2 weeks from the date of the test report

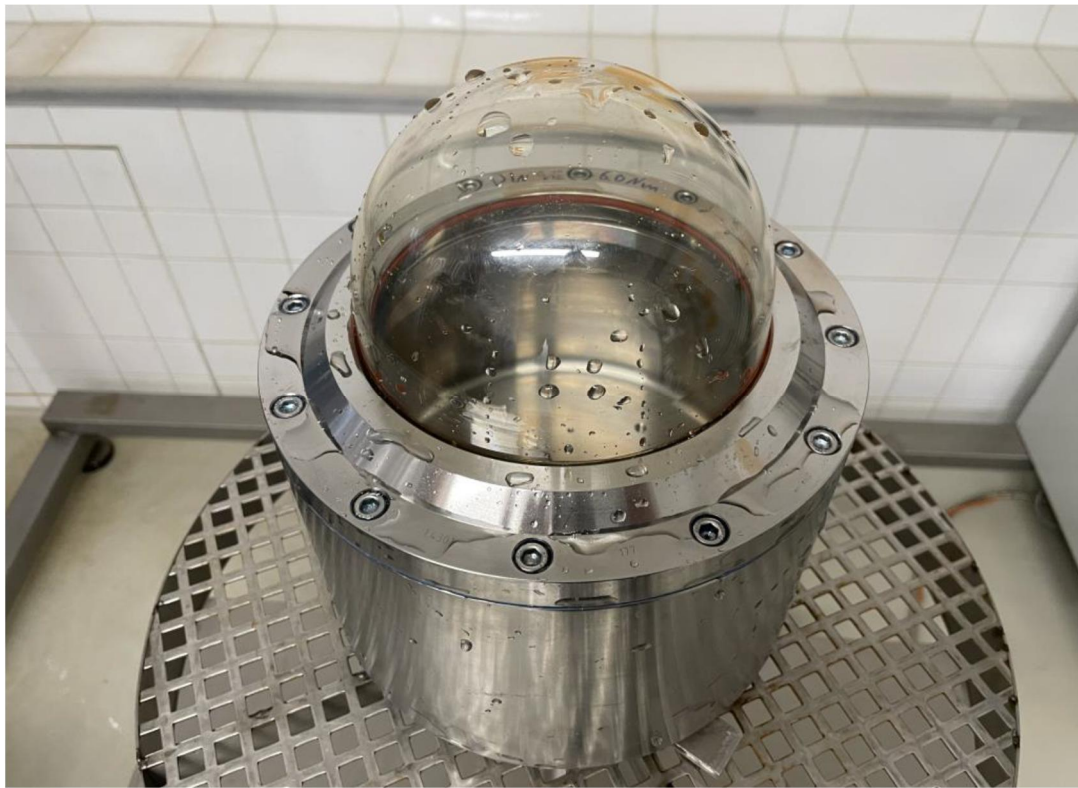
Fig. 9: Test specimen 004 after the strong water jet test IPX6 - No water ingress inside the enclosure; water accumulation between outer red and black seal

The test specimens were individually fixed on the turntable of the water jet device and exposed to the strong water jet load IPX6 (**Tab. 1 and 2**). At the end of the 3-minute exposure period, the test specimens were dried externally with a fleece and visually inspected for water ingress through the respective viewing pane. During the visual inspection of the test specimens through the viewing window, no water ingress into the inside of the housing was detected (Fig. 2 to Fig. 9). In the case of test specimen 004, a slight accumulation of water was detected between the red and the black seal of the cover (Fig. 9).

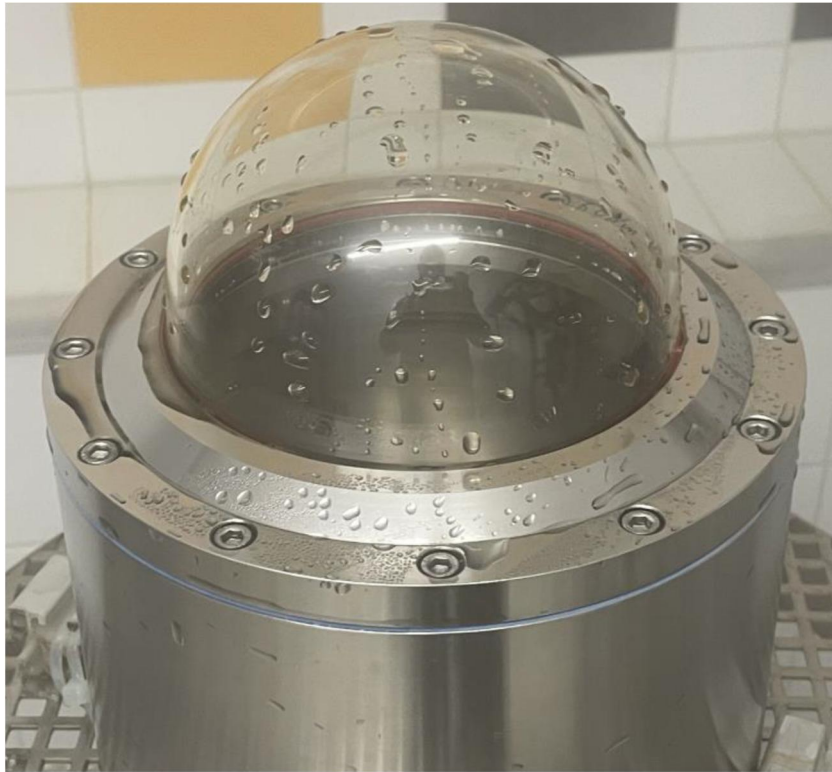
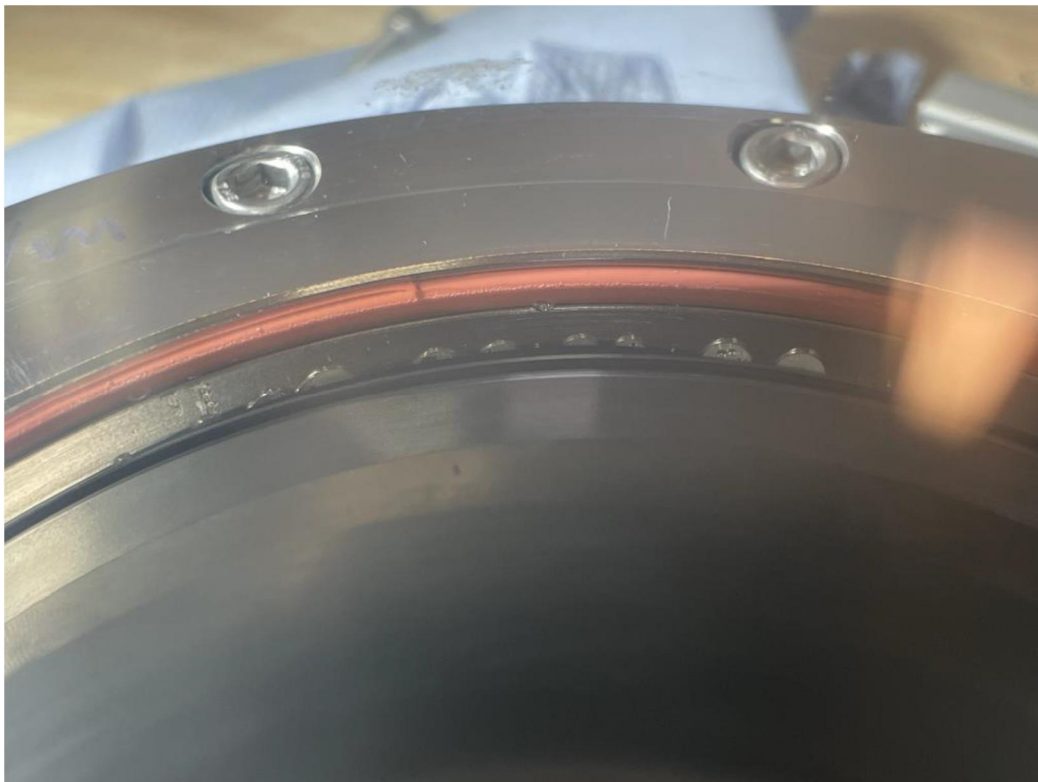
Fig. 20: Test specimen 004 after the steam jet test IPX9K - no water ingress inside the enclosure; water accumulation between outer red and black seal

The visual inspection of the test specimens did not reveal any water penetration into the interior of the housing (**Fig. 10 - 21**). In the case of test item 004, a slight accumulation of water was detected between the red and the black seal of the cover (**Fig. 20 and 21**). Further inspections will be performed by the customer.
